606 Main St, Laurel, Maryland 20707
Property Inspection Report-V8
Prepared for

Apr 29, 2022 at 08:00 AM

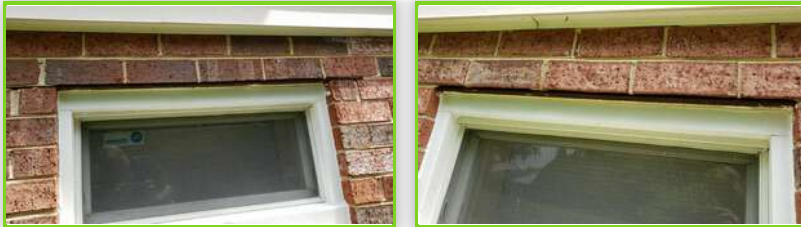
2.1.2 MISSING MORTAR AT STEEL LINTEL

Mortar missing above the door/window where the steel lintel extends into the brick. This is quite common in masonry walls and easy to correct. It is important to seal this open mortar joint in order to prevent corrosion of the steel lintel, which will expand and damage the brick further.

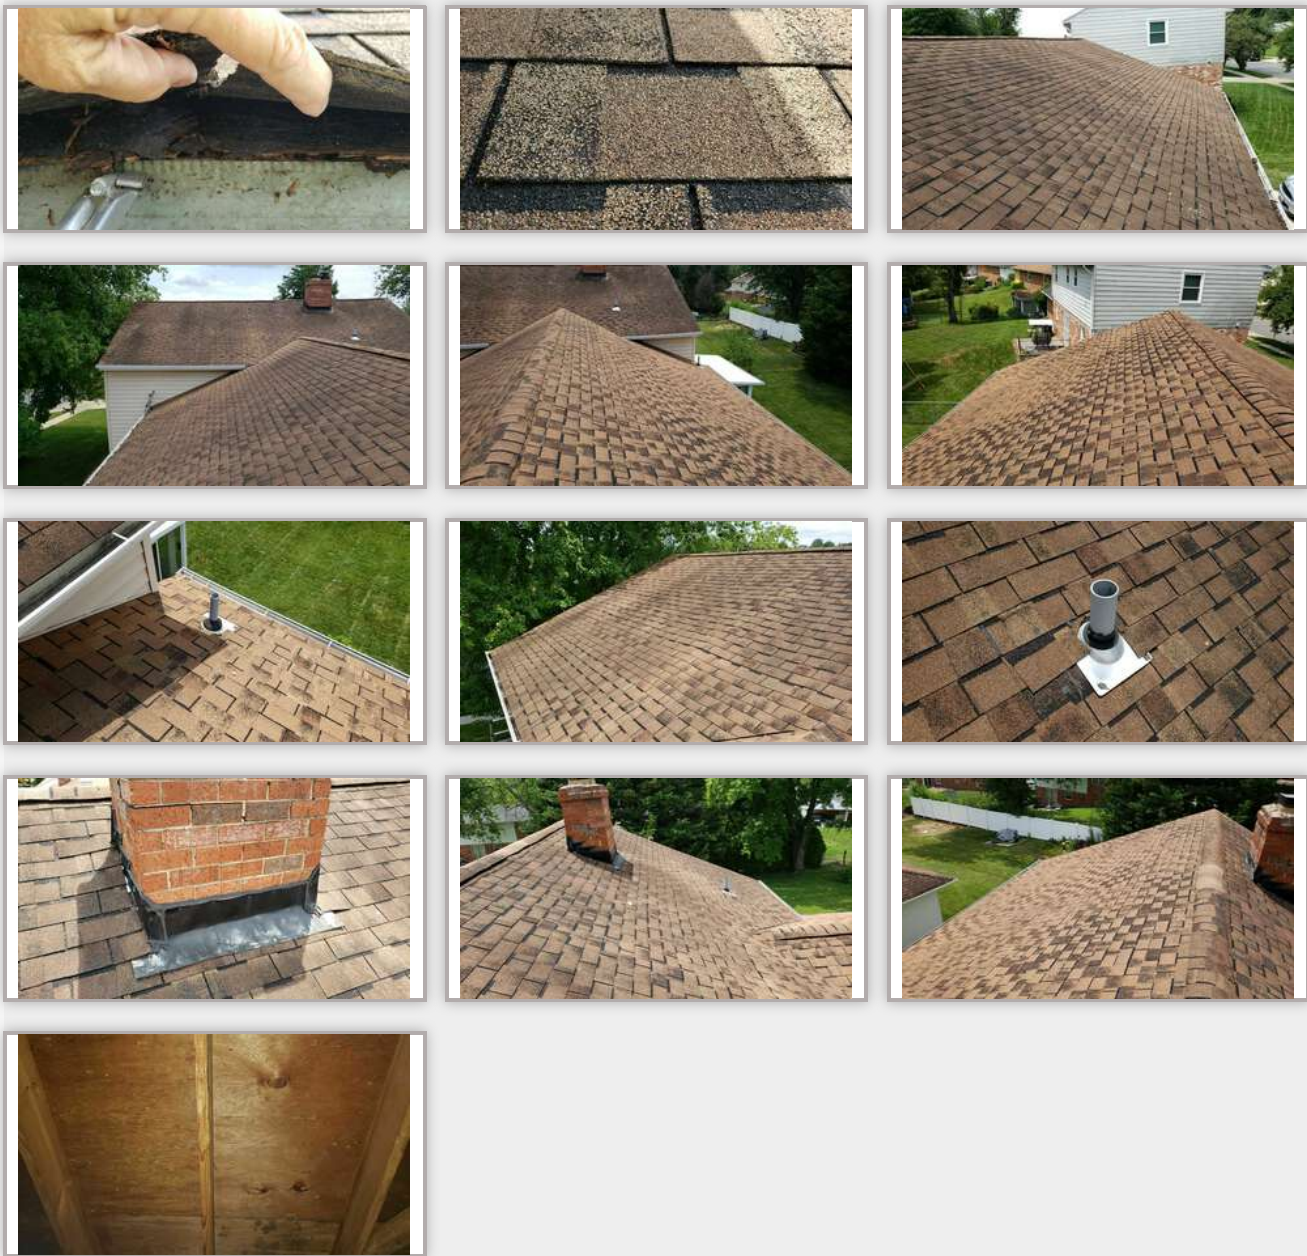
The roof covering is old, and approaching the end of its useful life. The roof cover has torn shingles that need addressed to prevent moisture entry into the building envelope. One area has been repaired. There is also a nail protruding that should be sealed to prevent moisture entry. Several areas have caulk applied as a temporary repair to help reduce potential leaks. The covering will need to be replaced. Recommend all flashings be replaced, sheathing checked for damage and ventilation issues be addressed at that time.

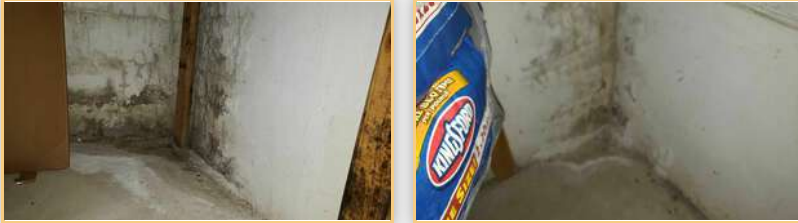
Efflorescence (white powdery substance on block walls) occurs with all concrete. Efflorescence is visible on concrete surfaces. Efflorescence is caused when soluble salts and other water dispersible materials come to the surface of concrete and mortars. It's induced by low temperatures, moist conditions, condensation, rain, dew, and water added to the surface of fresh concrete to assist troweling. It can occur very soon after exposure to moist or cool conditions or gradually, especially when it comes from within the concrete or from the subgrade. Any material containing Portland cement results in efflorescence. In this case the efflorescence is minimal and does not pose any more than a visual distraction. It can be minimized by eliminating the moisture source, which is believed to be due to the listed site drainage issues. For other approaches see link below. <http://www.aldonchem.com/popup-ab-efflorescence.htm>

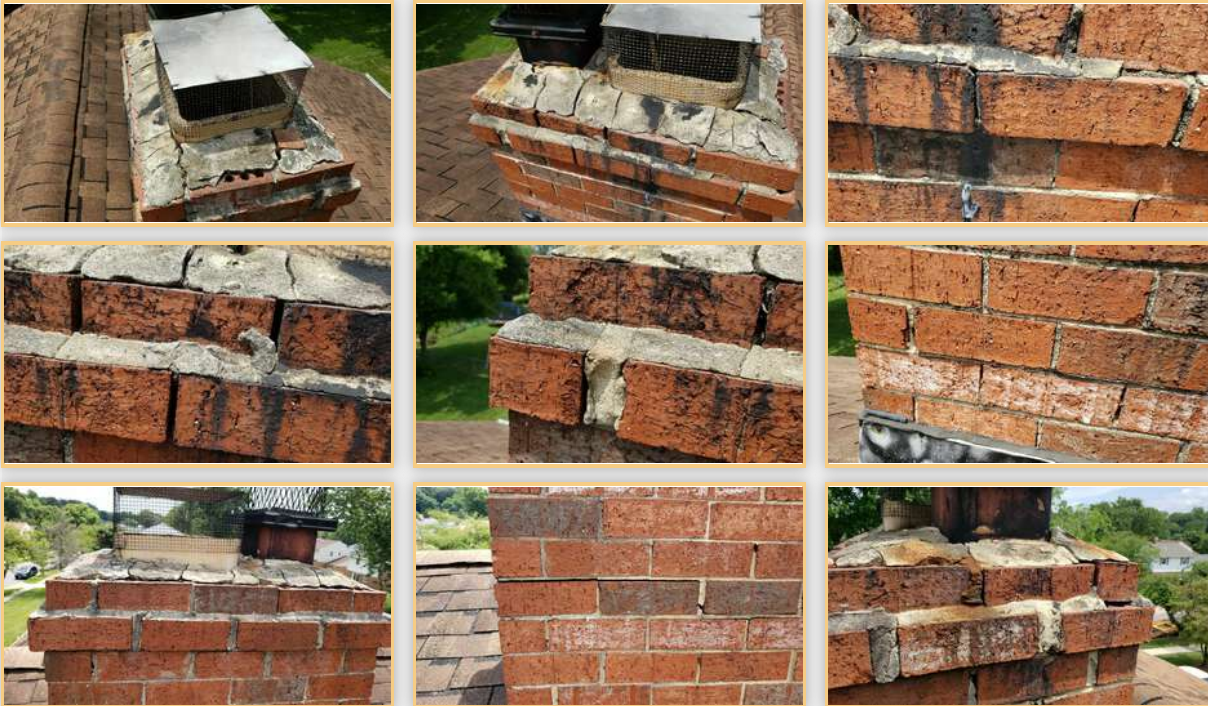
The chimney crown is failing, and just under the crown mortar joints are weak, if not repaired, further deterioration will occur. Proper chimney maintenance is essential to ensure the safe removal of exhaust fumes from furnaces and fireplaces. Note: The interior liner cannot be inspected without use of specialized equipment. Recommend having a qualified contractor repair the cracks, re-grout the chimneys as needed and check for any additional repairs that may be needed.
