606 Main St, Laurel, Maryland 20707
Property Inspection Report-V8
Prepared for

Apr 29, 2022 at 08:00 AM

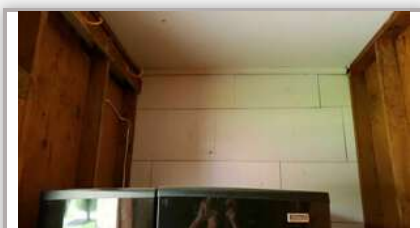
CARPORT SHED INTERIOR WALL

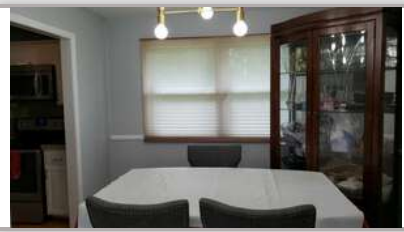
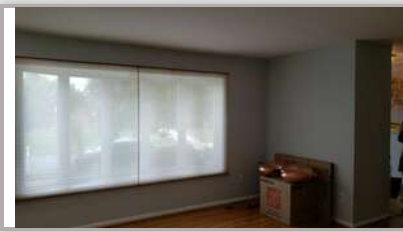
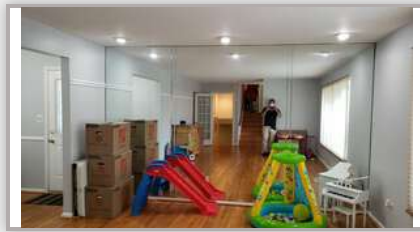
4.1.1 CEILING WATER STAIN-ROOF LEAK

Signs of water stains are present on the ceiling. We did not detect the presence of moisture which suggests this is not a recent occurrence. The underlying cause is moisture or dampness related a past roof leak. Could not determine if this is an ongoing issue.

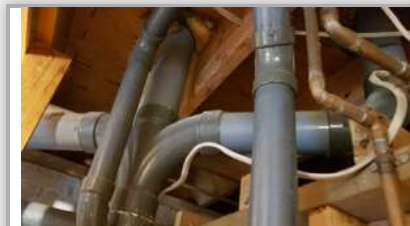
MAIN WASTE LINE

FYI: The subject property appears to have the original cast iron drain pipes installed. There were no outward visible signs of adverse conditions during the inspection. Note: Cast iron pipes are no longer used for drainage in homes due to its aging and deterioration over time. These pipes should be inspected periodically. Cast iron pipes eventually corrode from the inside inhibiting flow and or start to leak and will eventually need replacement. Recommend internal inspection (Sewer Scope) be performed to determine waste line condition.

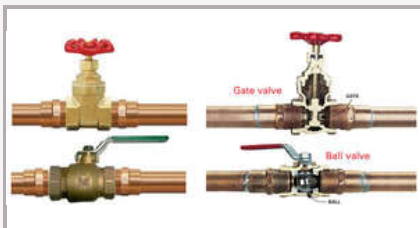
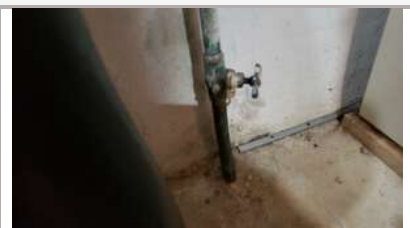
LOCATION: BASEMENT ALONG THE FRONT WALL

WATER MAIN LOCATION

The attached photo shows the water main valve. Customer advised to maintain easy access to this valve so that it can be turned off in the event of an emergency. Unused valves can get stuck if not used. Turning this valve once or twice a year can prevent the valve from sticking. Note: Older gate valves that have not been used in some time, may develop a slow leak. If your valve is a gate valve, consider having it replaced with a ball valve.

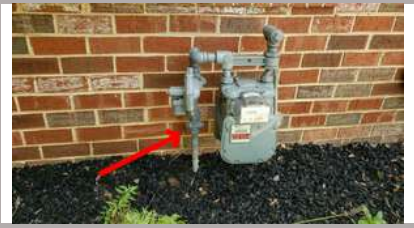
LOCATION: FRONT EXTERIOR

GAS MAIN LOCATION

The attached photo shows the gas main valve at the gas meter. Customer advised to maintain easy access to this valve so that it can be turned off in the event of an emergency. Note: This valve can only be turned with a wrench.

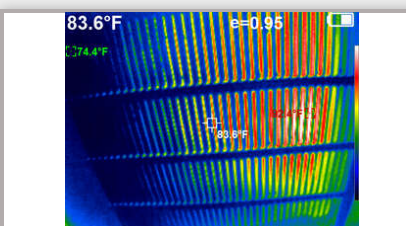
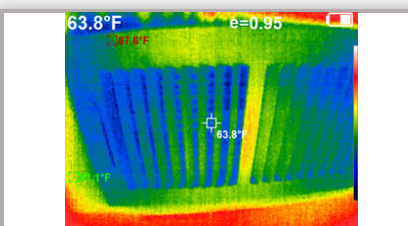
THERMAL IMAGE OF RETURN AIR TEMP

THERMAL IMAGE OF SUPPLY AIR TEMP

The ambient air test was performed by using thermal imagery on the Air conditioner to determine if the difference in temperatures of the supply and return air are between 14 degrees and 22 degrees which indicates that the unit is cooling as intended. The images shown indicate the range in temperature drop is normal.
